Building America Case Study Technology Solutions for New and Existing Homes

Interior Foundation Insulation Upgrade—Madison Residence

Madison, WI

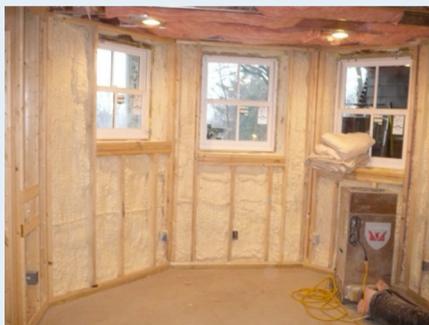
Foundation wall, after installation of all moisture and thermal management layers. The space is now ready for finishes.

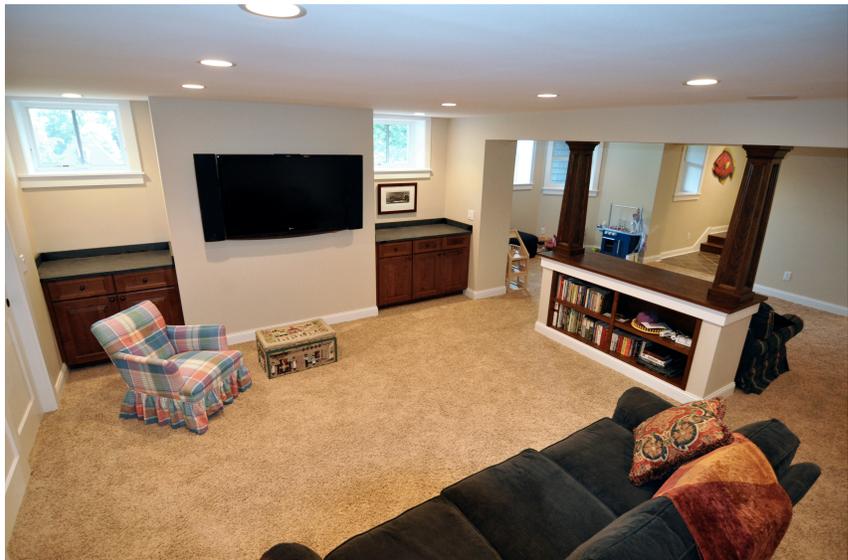
Photo showing finished basement space. Extensive moisture management and insulating efforts result in a warm, dry living space below grade.
